1. REPORT NUMBER CERL-TR-M-120	2. GOVT ACCESSION NO.	3. RECIPIENT'S CATALOG NUMBER AD-A008 996
4. TITLE (and Subtitle) FAILURE ANALYSIS OF TAINTER GATE CABLE-ADJUSTING BOLTS		5. TYPE OF REPORT & PERIOD COVERED FINAL

FAILURE ANALYSIS OF TAINTER GATE CABLE-ADJUSTING BOLTS

Objective and Scope. The objective of this investigation was to determine the cause of failure of the eight cable-adjusting bolts at Uniontown Dam and to recommend a means to minimize the probability of future failures.

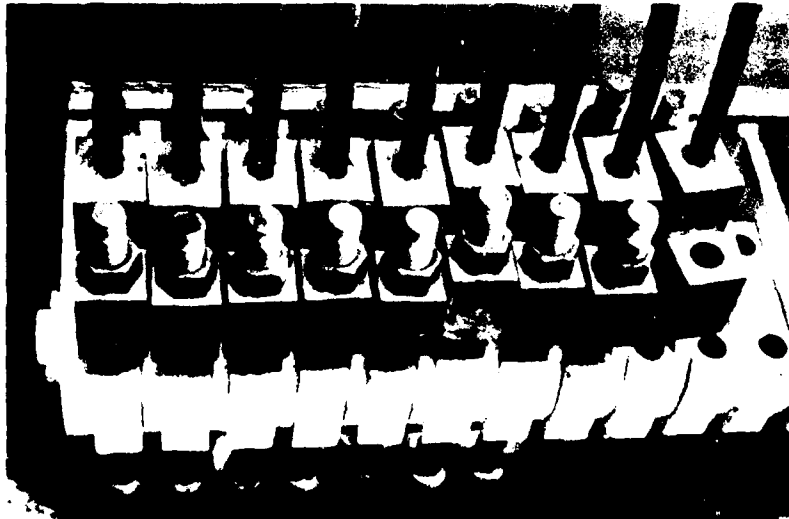
Figure 2. Bolt assembly securing lifting cables.

g. The high-velocity, turbulent water flow at the ends of the Tainter gates imposes a cavitation erosion condition on the bolt assembly. This condition should be eliminated by installing baffles or a protective cover for the bolt assembly in long-term applications of this Tainter gate design.

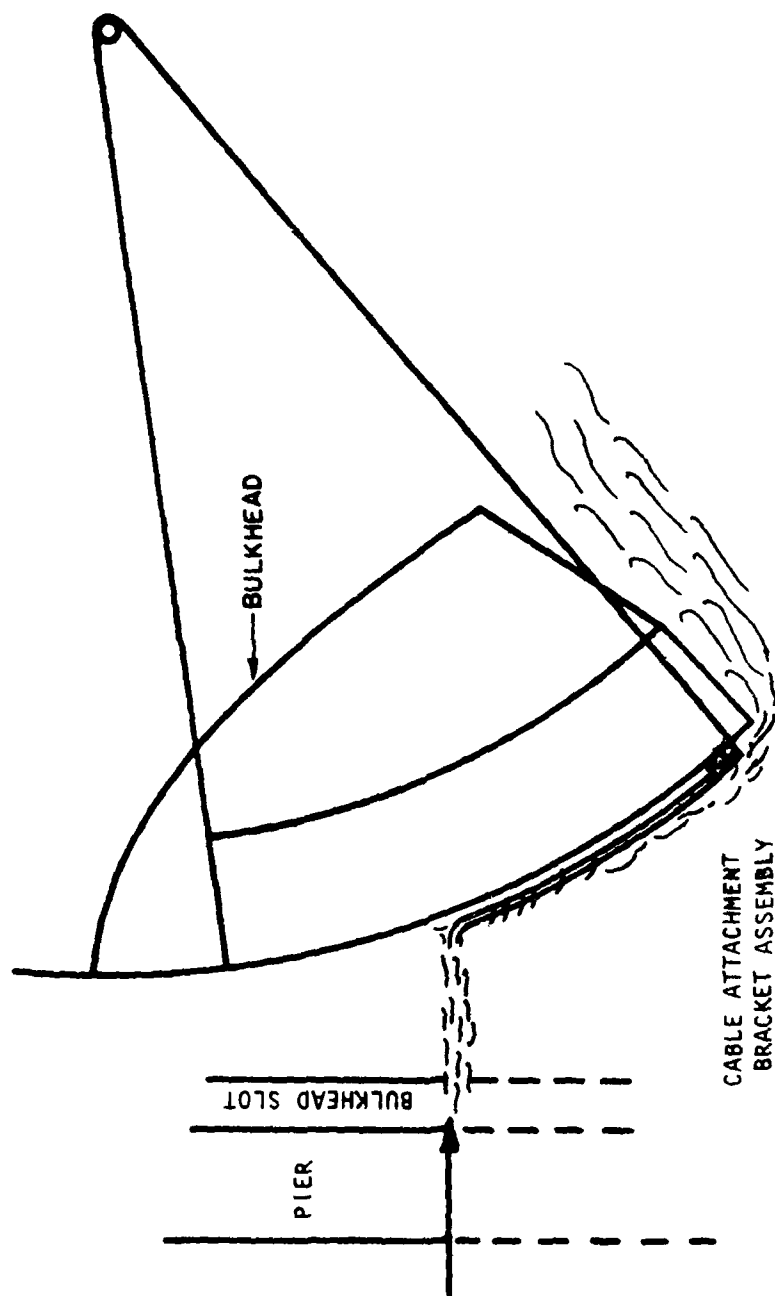
The current cable attachment assembly is a modification of a previous design used at the McAlpine and Cannelton Locks and Dams. In the current design, shown in Figure 3, the assembly is located on the face of the gate. In the previous design, illustrated in Figure 4, the cable was wrapped around the gate, and the bolt assembly was located on the opposite side of the gate. The cable was therefore able to transfer part of the load to the gate itself instead of applying it all to the bolt assembly. The bolts used were forged from type 304 stainless steel, which has less strength but more corrosion resistance than the type 416 stainless steel used in the new design. There have been no known bolt failures on dams using the older design.

Figure 3. Sketch of Tainter gate at Uniontown Locks and Dam.

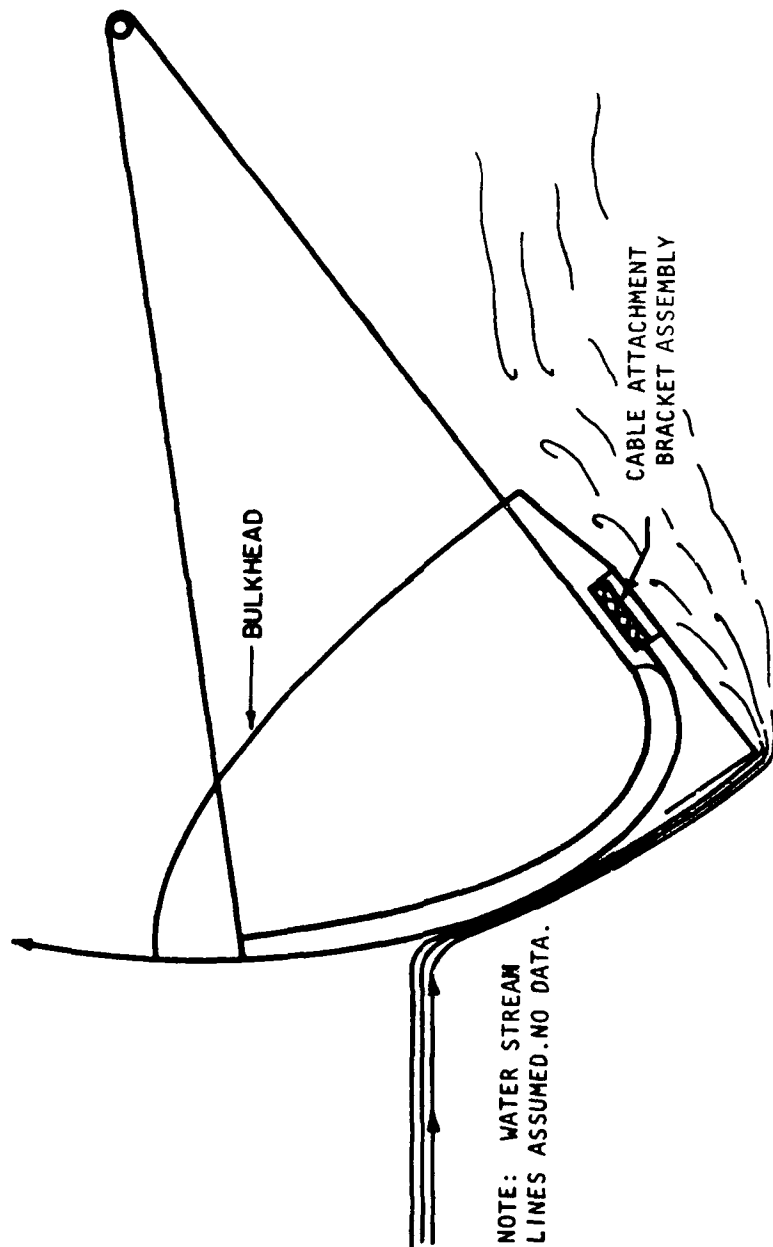
Figure 4. Sketch of Tainter gate at McAlpine Locks and Dam.
